SUMMER 2005

# Flight Comment

- *Transformation Project*
- *Flight Data Monitoring  
— A Proactive Approach to Safety*
- *Tail Rotor Half Hub*

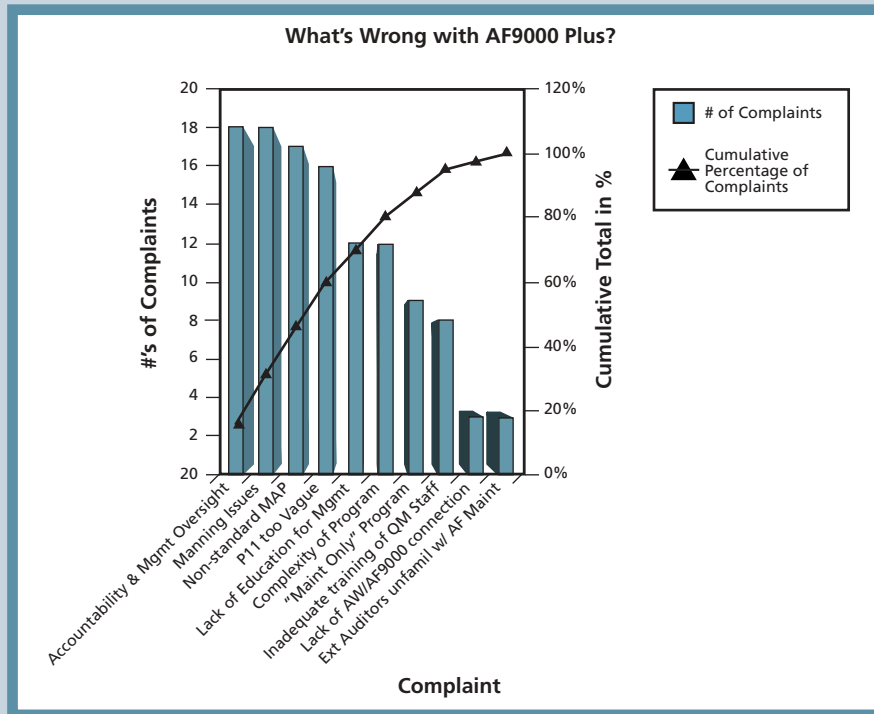
The AF9000 Plus Transformation Project was stood up to address this situation. With A4 approval of the project charter on 24 February 2005, the 1 Canadian Air Division Head Quarters A4 Aerospace Quality Management (AQM) section was given clear direction and an aggressive timeline to resolve the problem. Our first task was to gather input from the field. Using the annual AF9000 Plus Quality Conference as our vehicle, we brought together the best and brightest from across the Air Force to help us. In a questionnaire sent out in advance of the conference, we asked Unit Quality Managers (QMs) to sit down with their COs and other senior management personnel to identify chief complaints with AF9000 Plus. Figure 1 shows the top ten responses:

Based on a Pareto Analysis of the questionnaire returns it was determined that the AF9000 Plus Transformation Project needed to address:
